Appendix B: Southern F528

Field Notes and Pictures

Utility: ComEd Investigators: J. Stutsman & J. Spencer

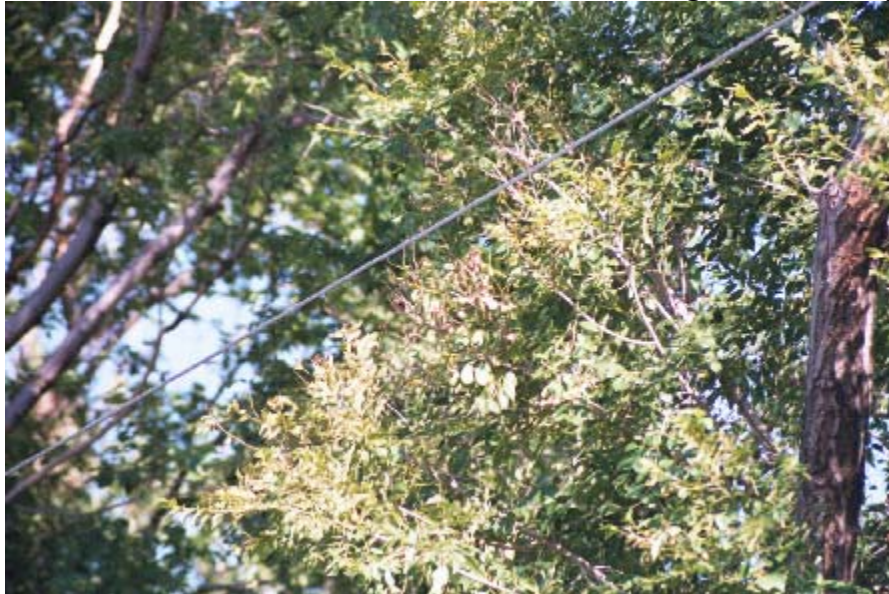
Picture B1

Bare conductor contact with tree with visible burning on tree in Lynwood
